ADAPTIVE REUSE POTENTIAL EVALUATION

March 2021

PREPARED FOR
The County of Sonoma

PREPARED BY
Hornberger + Worstell

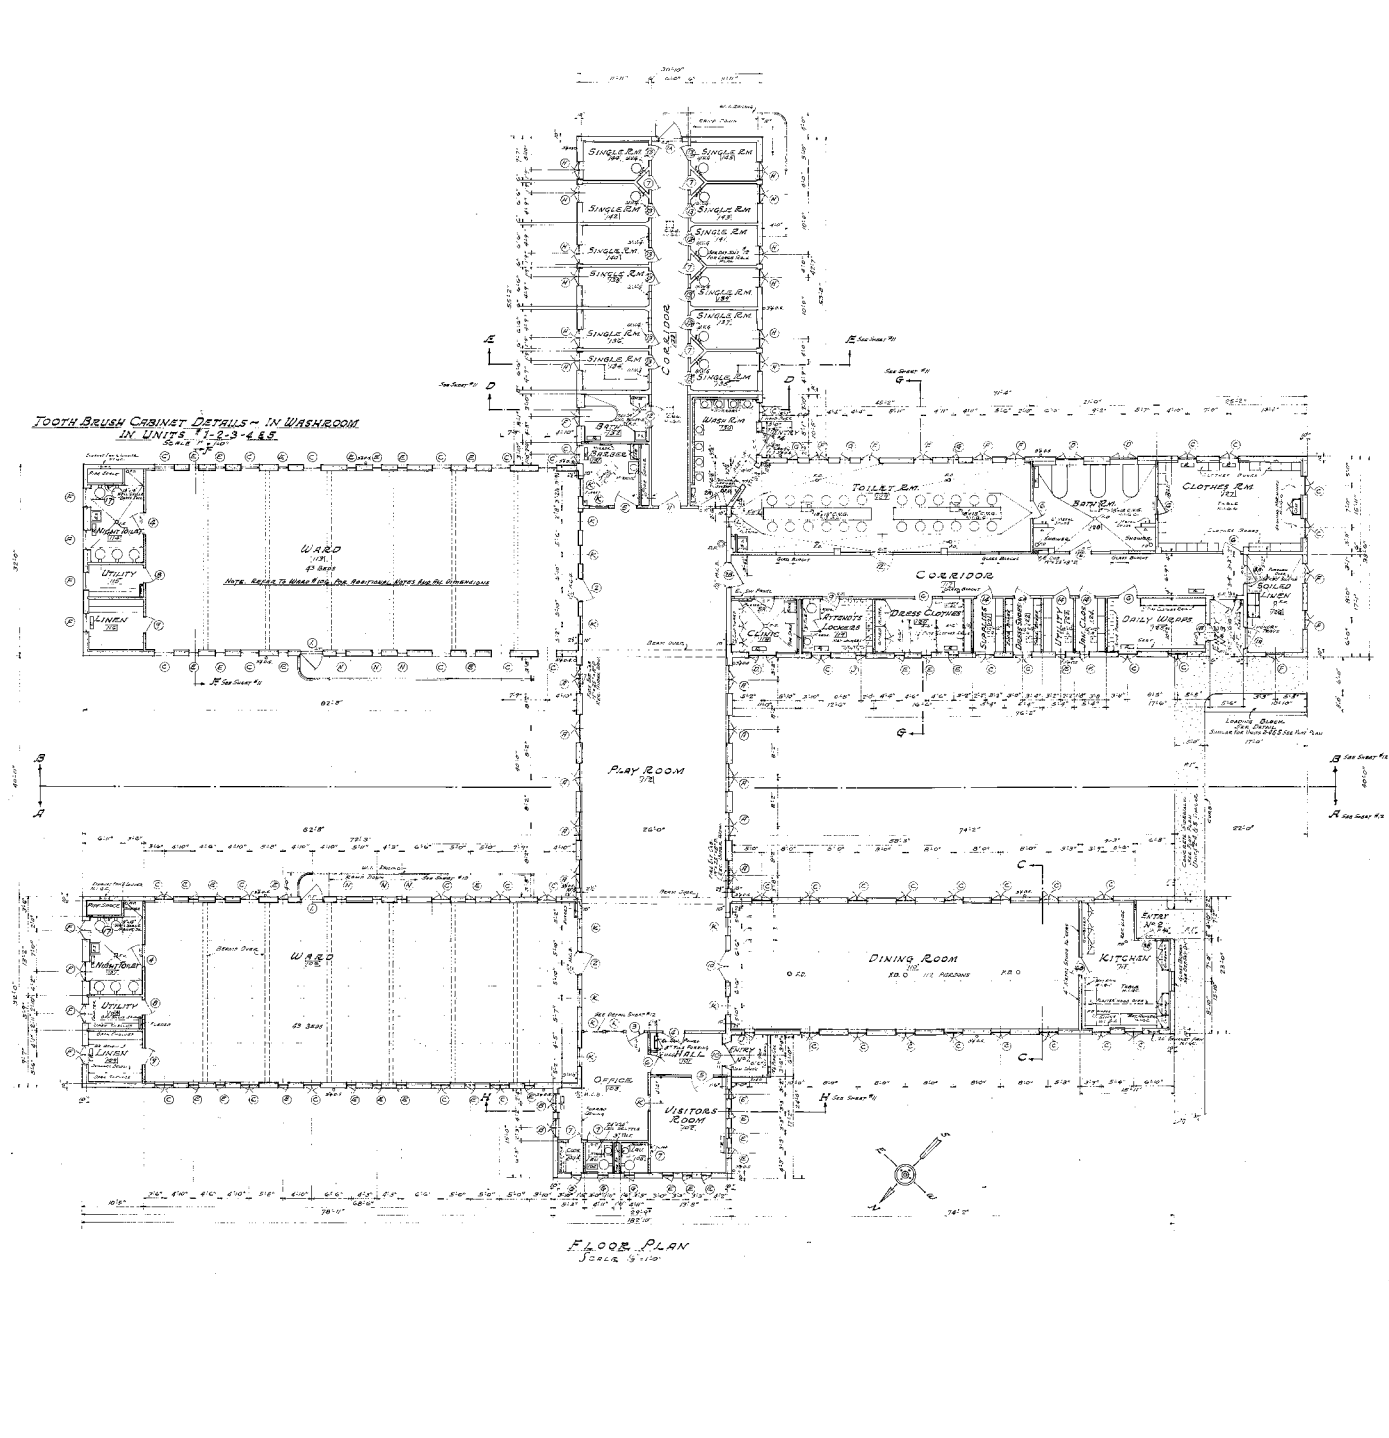
Original H-Plan 1 | Lux 1/32"=1'-0"

Client Residential Wards | Postwar H-Plan 1, 2 (similar) and 3 (similar)
Cromwell, Poppe, Stoneman, Lux, Lathrop; Bentley, Roadruck, Brent, Smith, Bemis, Judah; and Cohen, Malone, Corcoran

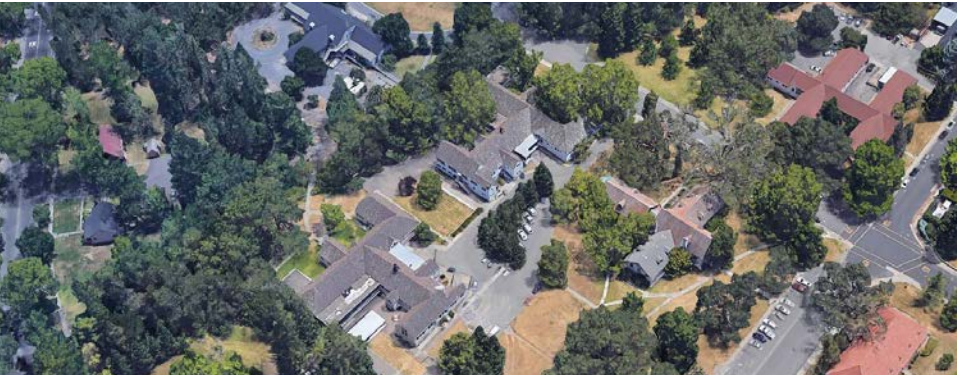
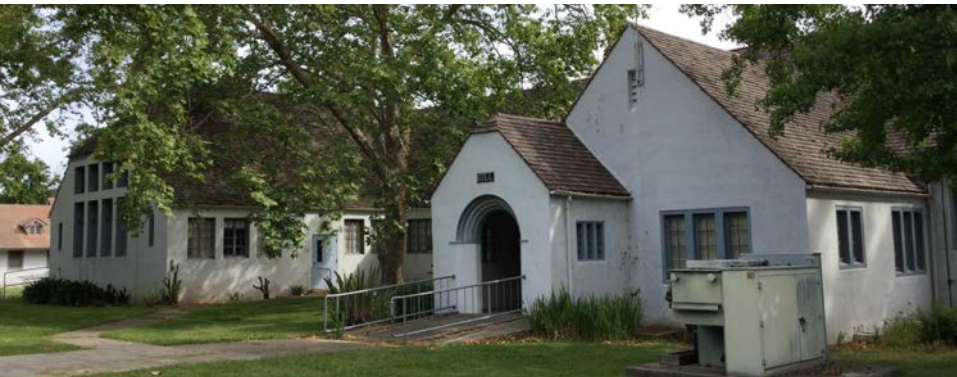
Hill and Osborne Cottages are concrete buildings of similar French Eclectic-style design built in 1940. The structures originally functioned as patient wards. Concrete docks were constructed in 1976, metal canopies constructed between 1976 and 1977, flat roof HVAC additions between 1958 and 1986, and windows and doors replaced at unknown dates.

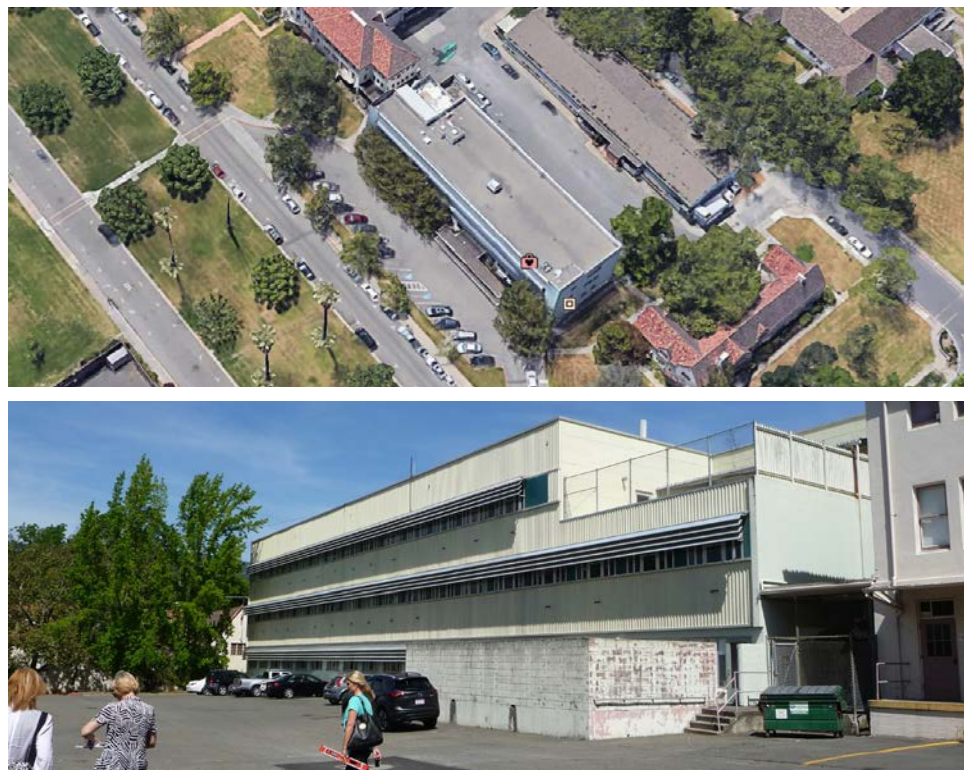
Although the building lacks historic significance, aside from the incorporation of ridged metal window awnings in the mid-1960s, the Frederickson Receiving Center appears unaltered since its construction; it appears to retain integrity of materials, design, workmanship, feeling, association, setting, and location.

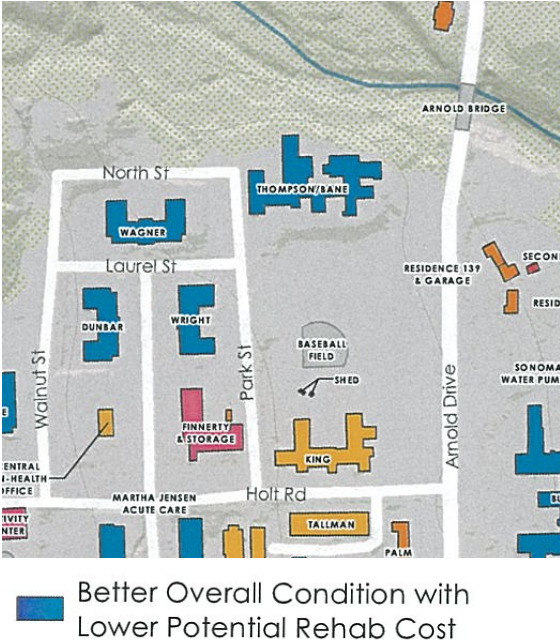
Rapid Assessment: Composite Conditions

Note: The Composite Conditions map combines the building assessments for Site, Building Materials, Structural, and Hazardous Materials with weighted averages for Potential Rehabilitation Cost to determine overall reuse potential based purely on condition.

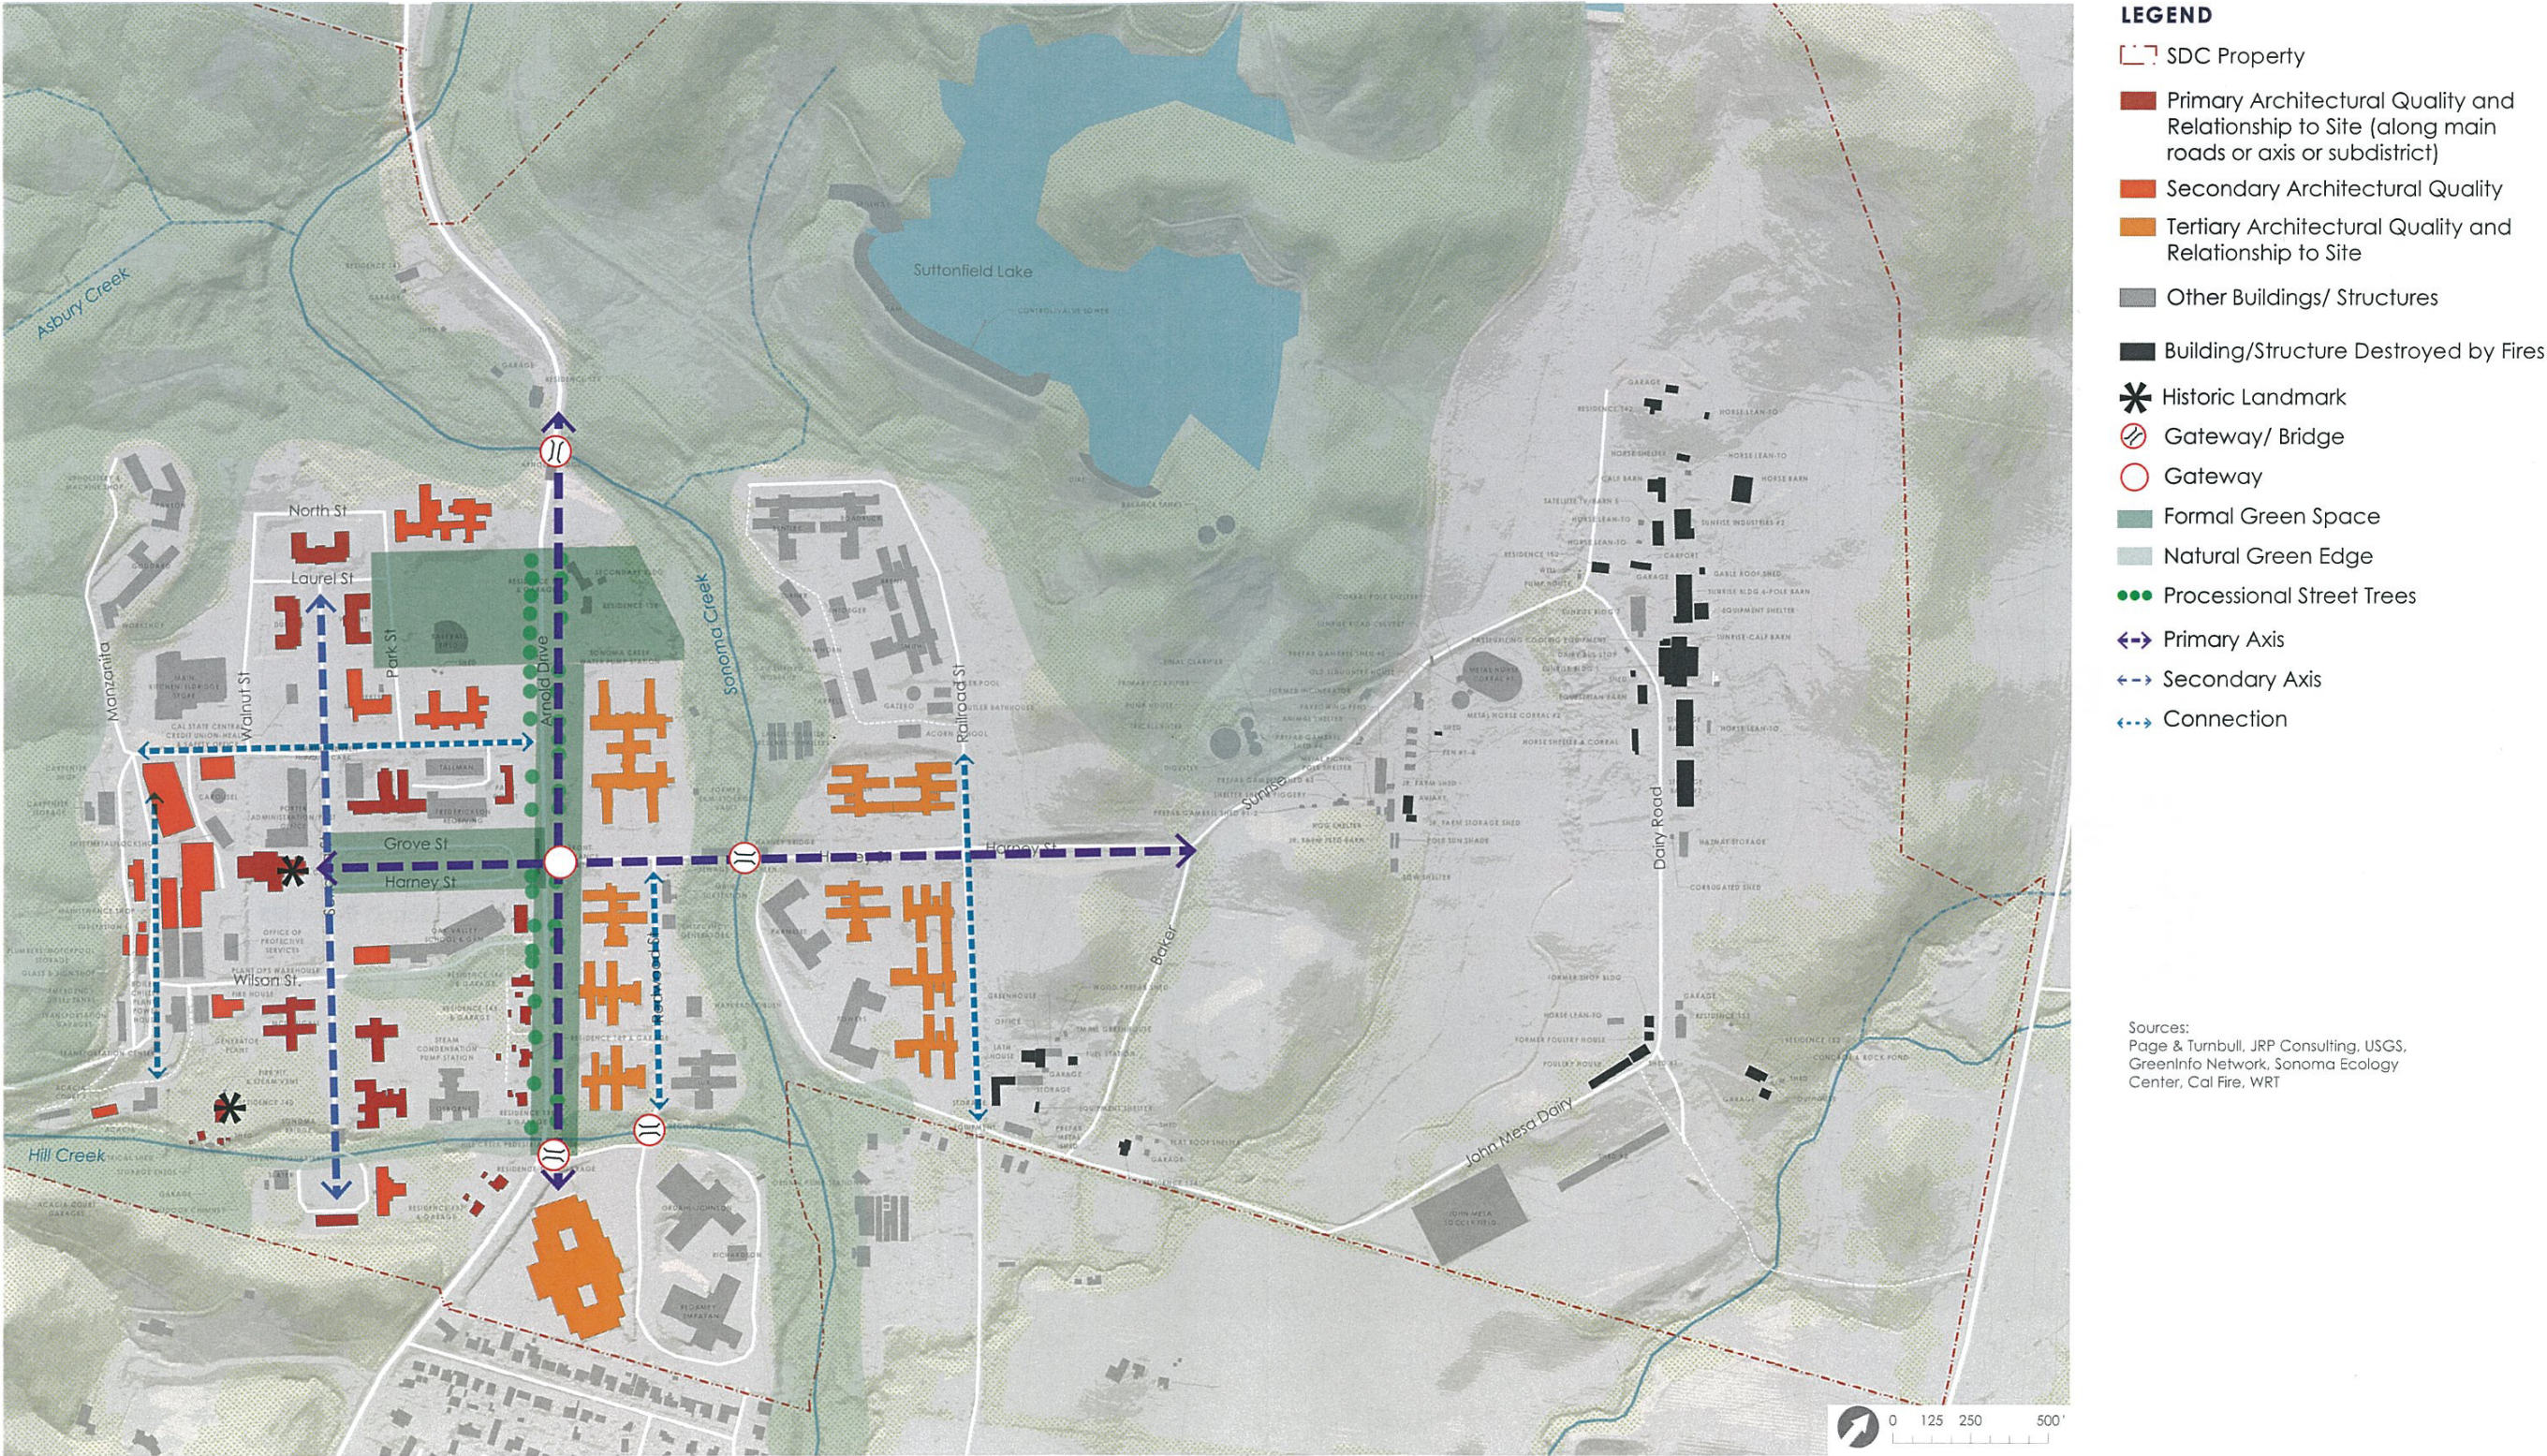
Figure B-3: Map of Historic District Contributors Per JPR Draft HRIER – August 2018

- Contributing Building
- Contributing Structure
- Non-Contributing Building
- Non-Contributing Structure
- JRP's Proposed Historic District Boundary
- SDC Property
